Proof-of-Value Inspection

**Mokena, IL 60448
(Sample Report)**

Inspection Report

- Storm Damage Report / Inspection Report

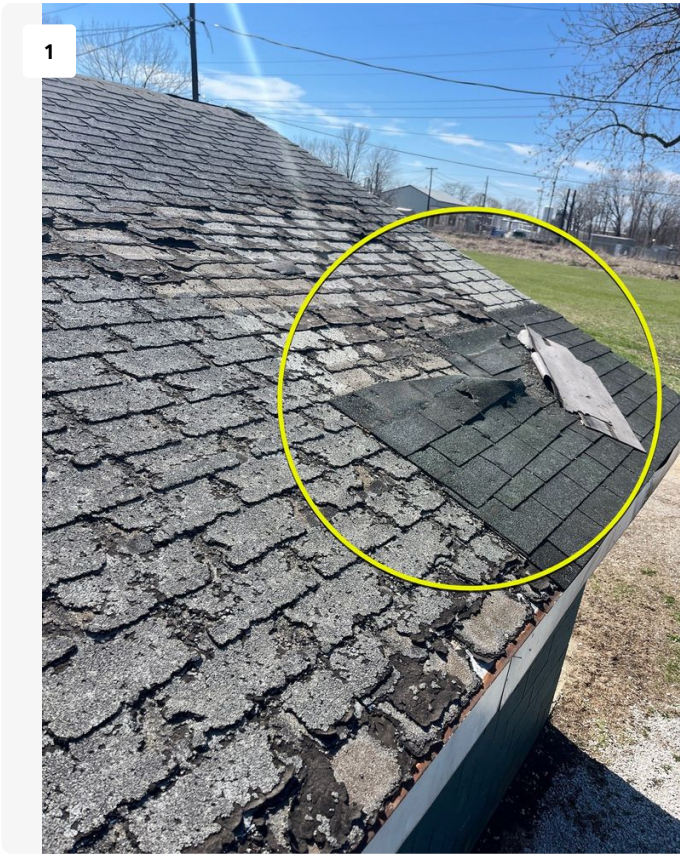
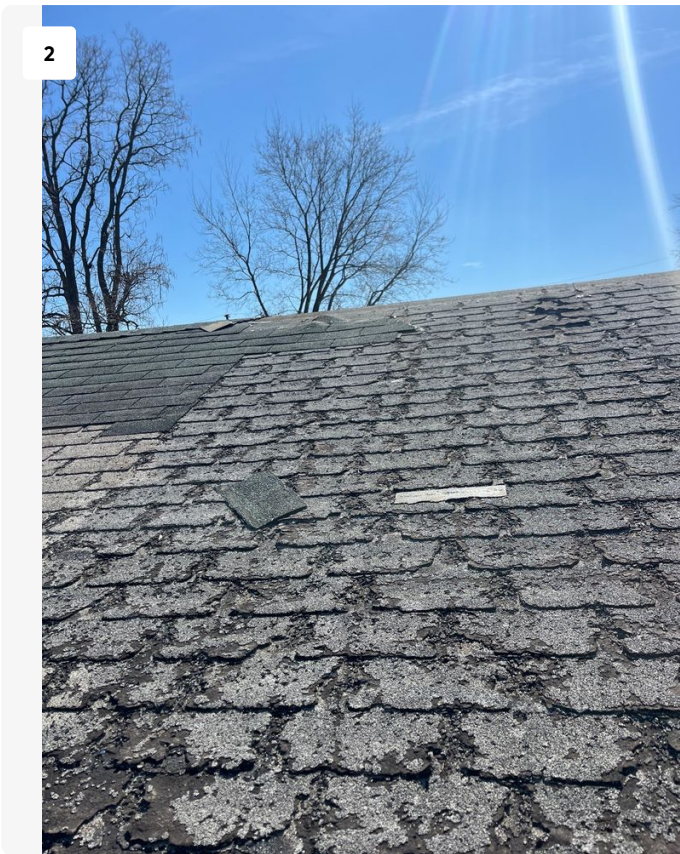
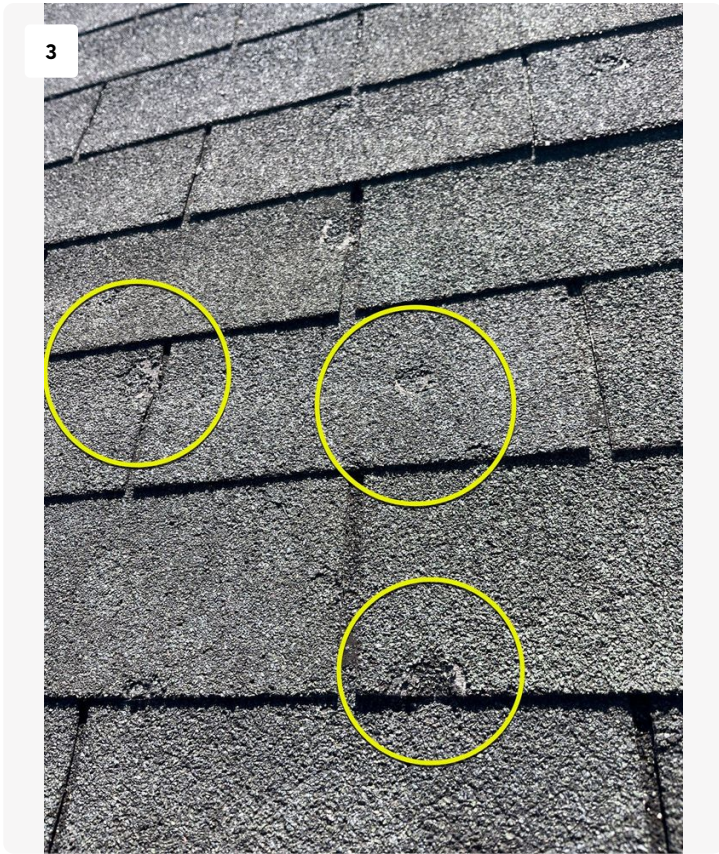
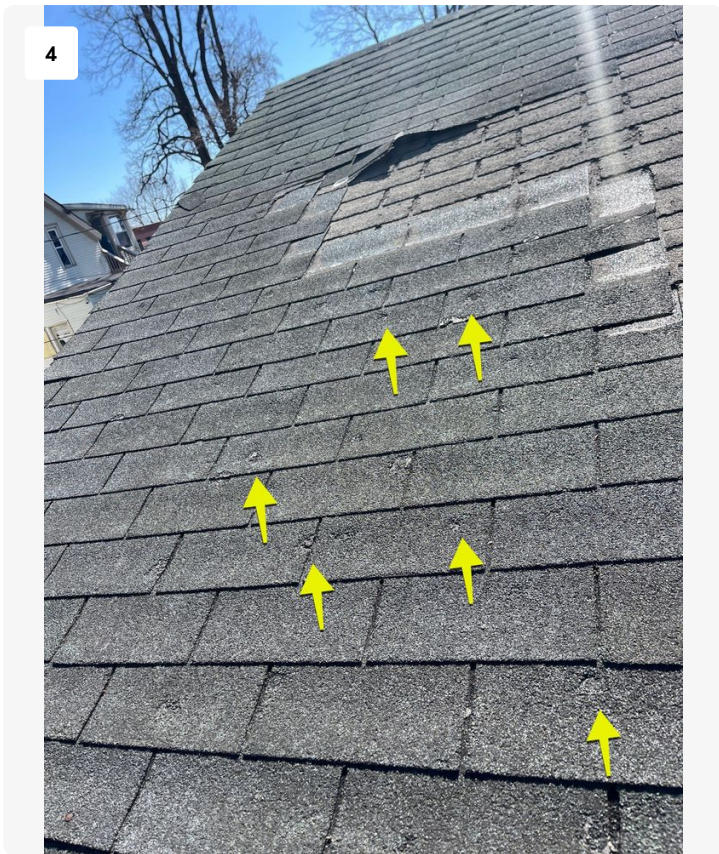
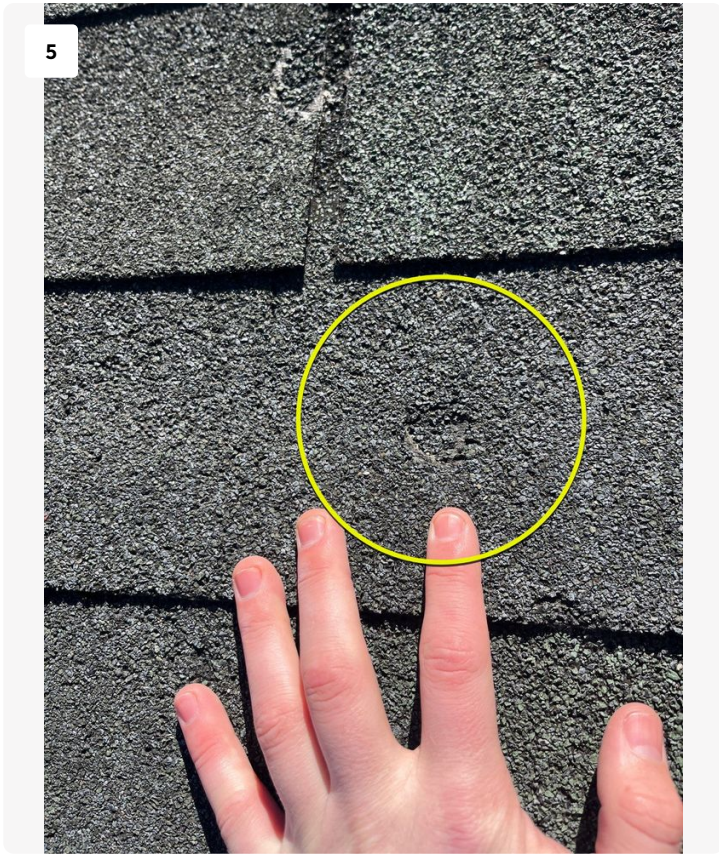
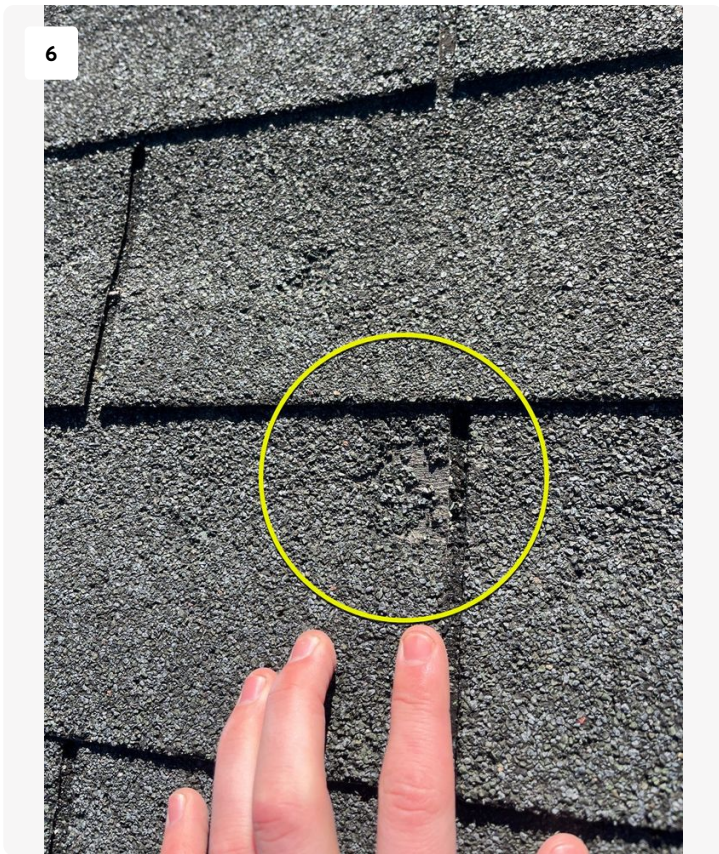
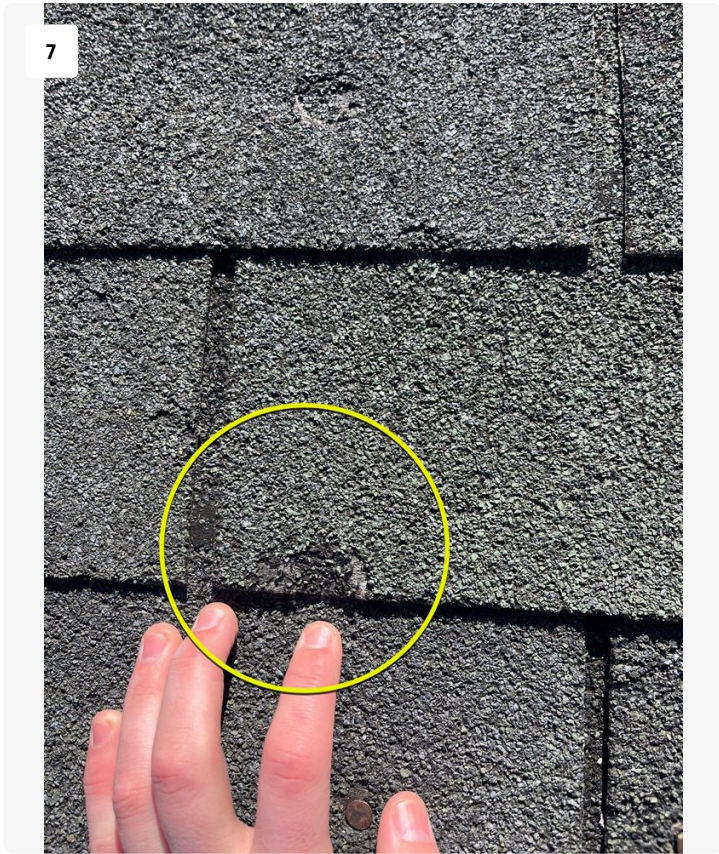
Detached garage damage photos 1-7

The roof systems on both the building and the detached garage sustained significant hail impact damage across all inspected elevations. Widespread hail strikes were documented throughout both roof surfaces, consistent with the March 10 storm event. The volume and distribution of impact activity across both structures indicates a hard hail event with considerable force. No elevation on either structure was spared from the observed hail activity.

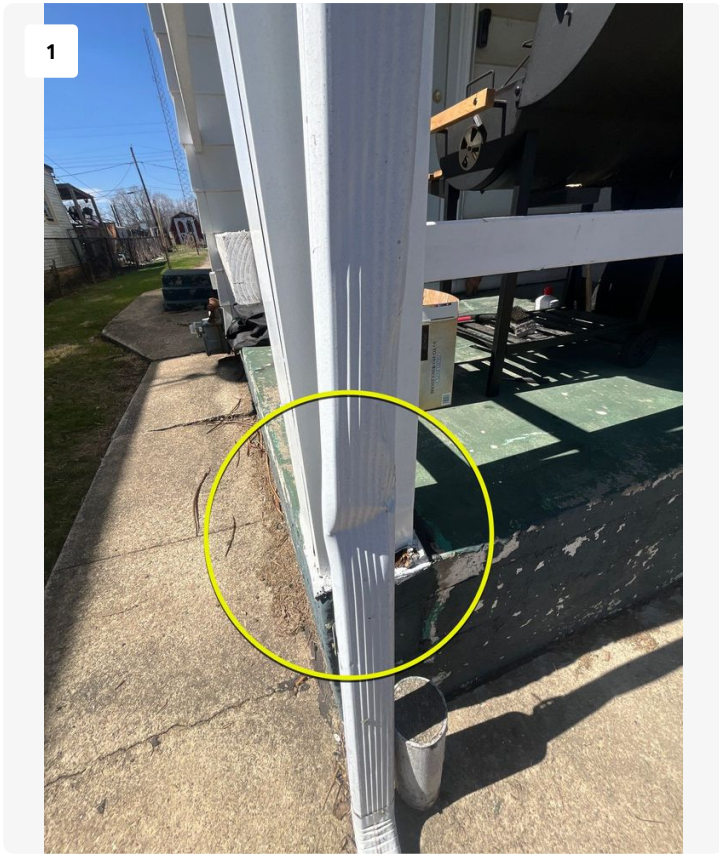
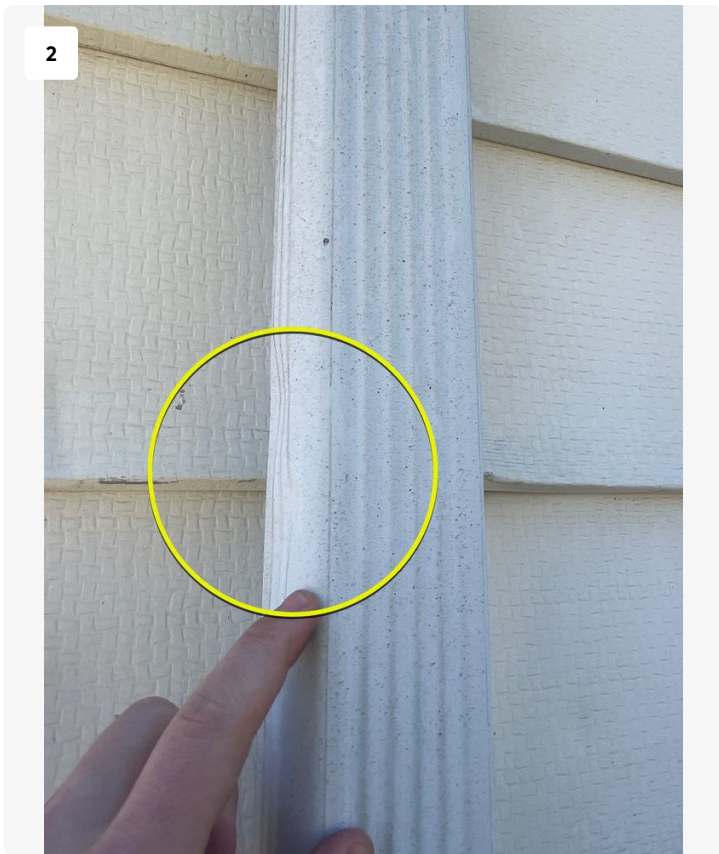
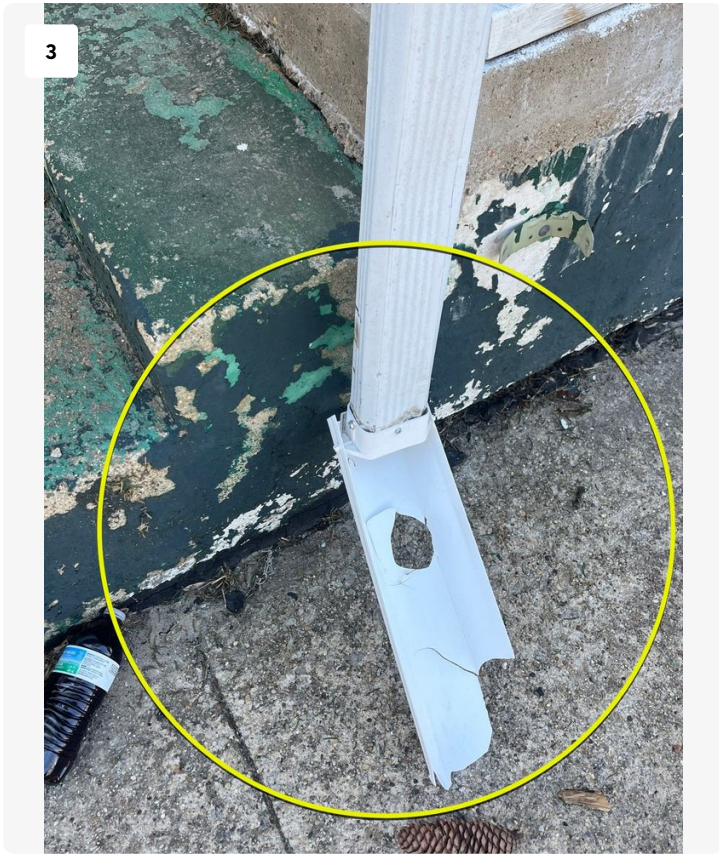
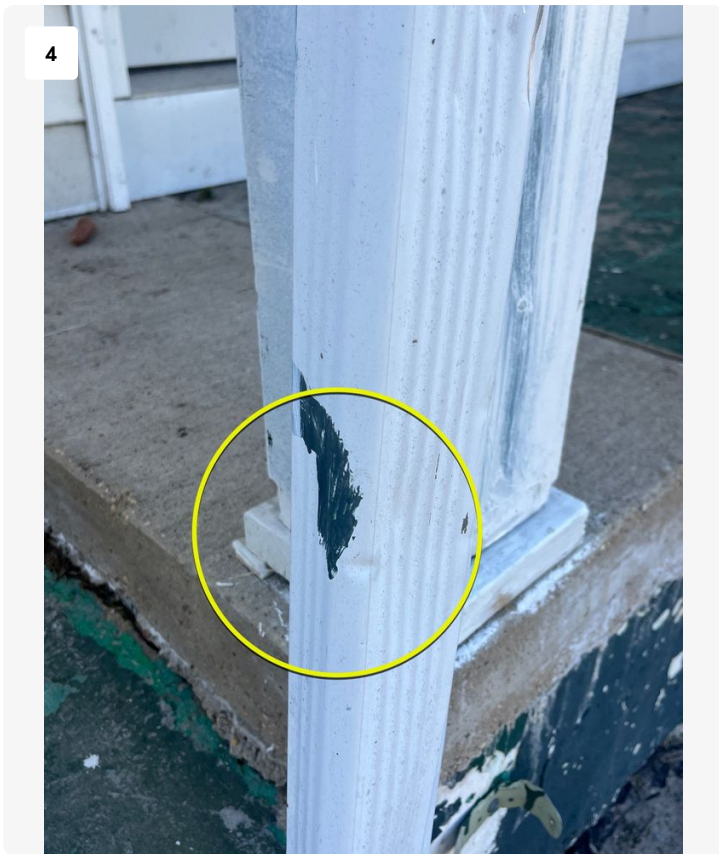
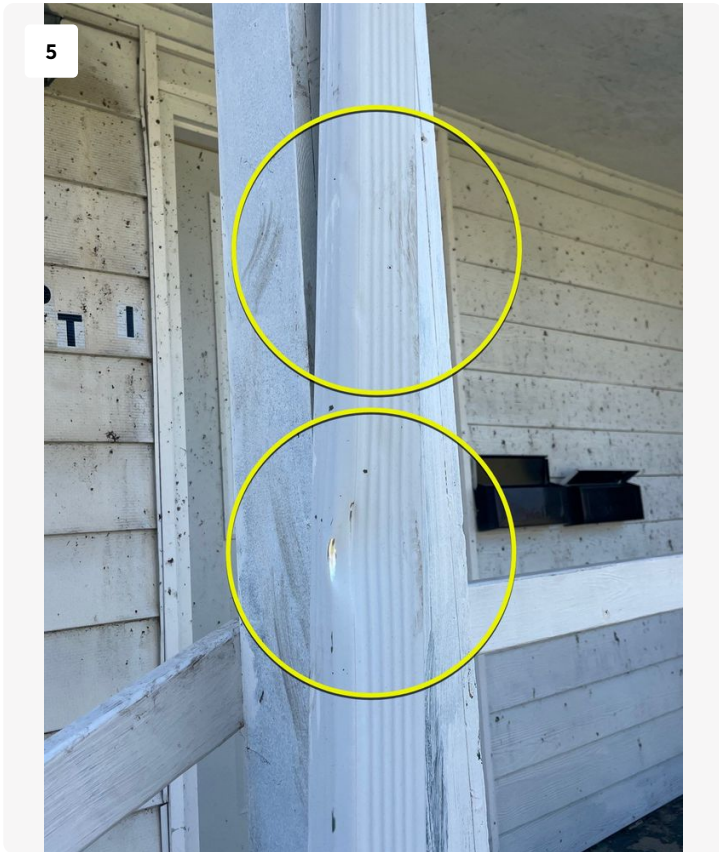
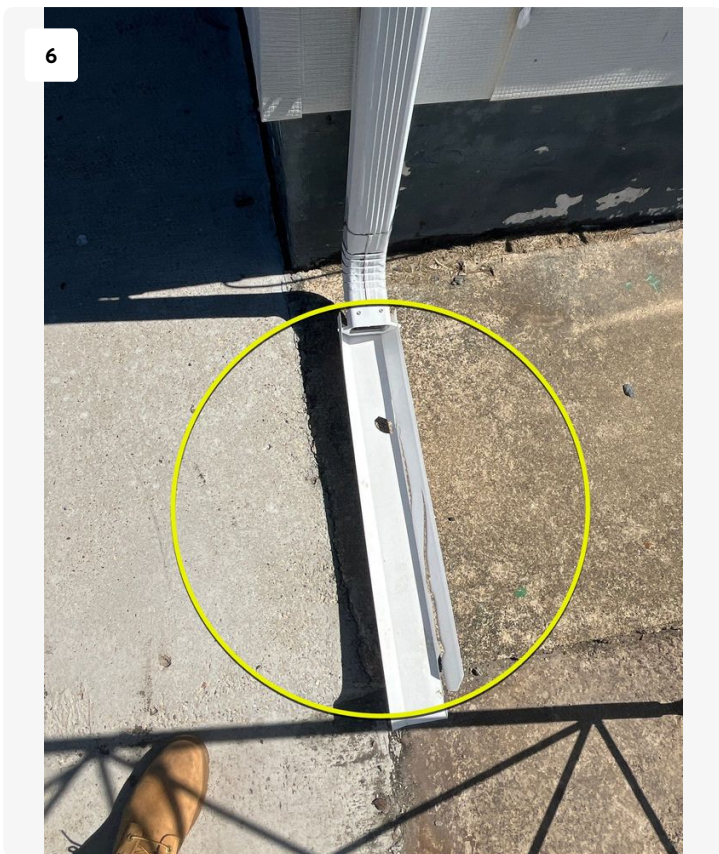
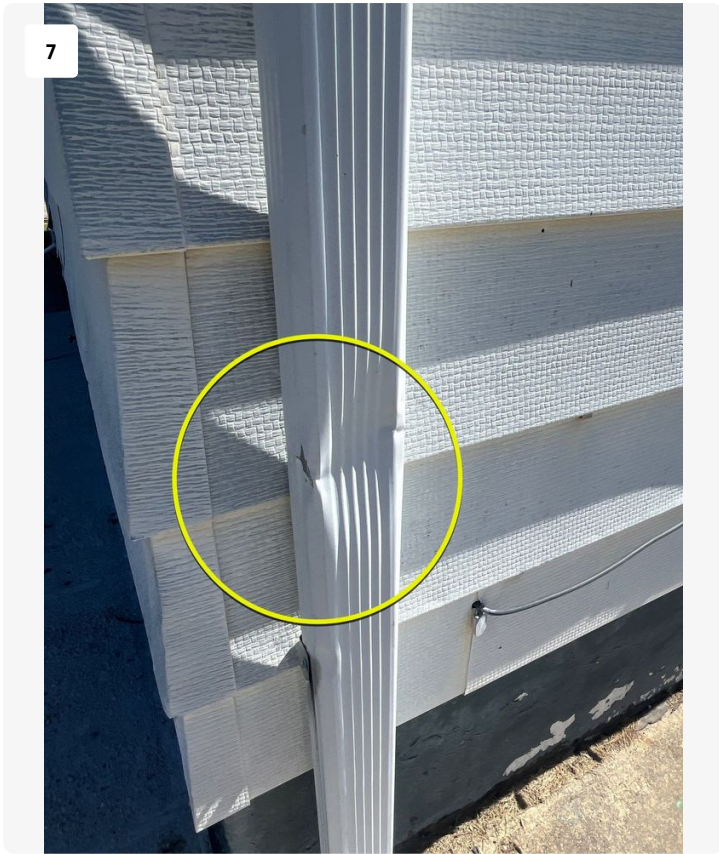
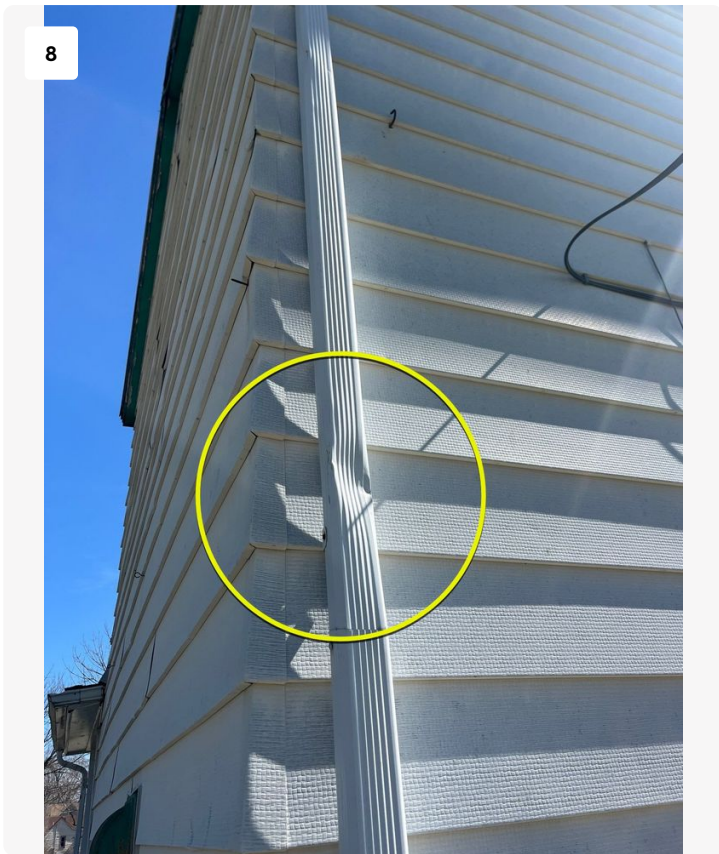
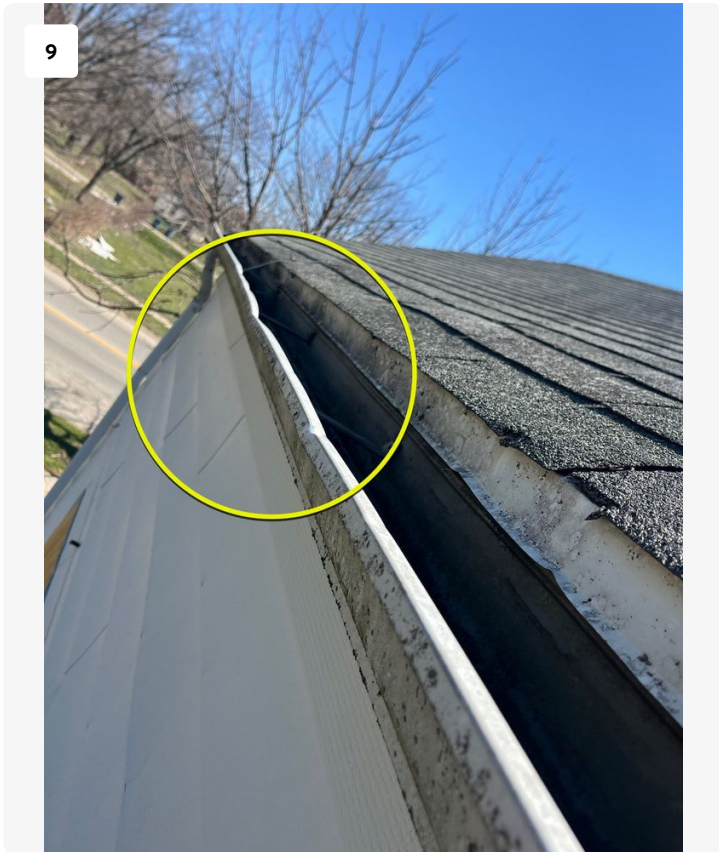
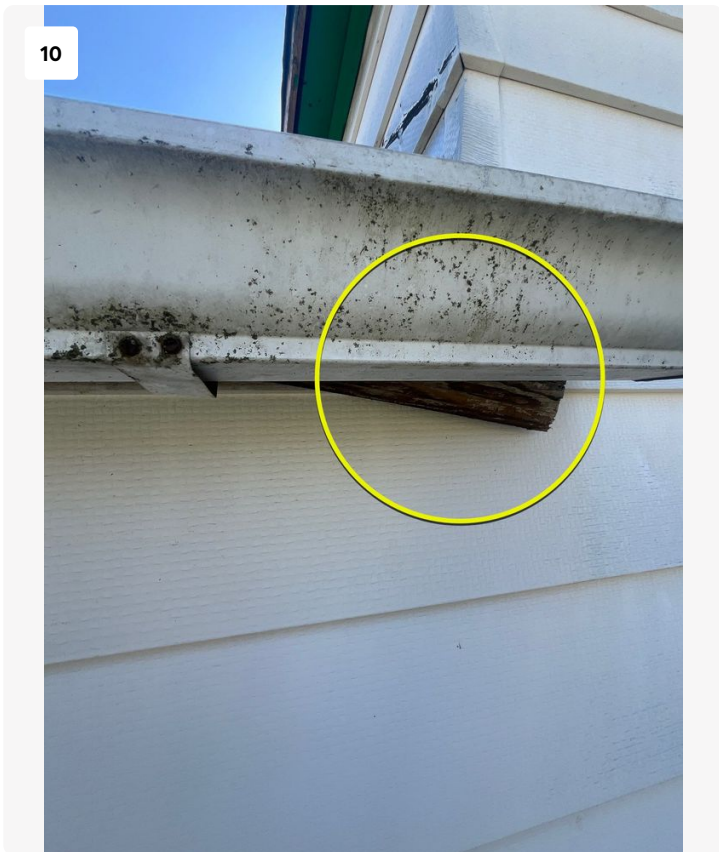
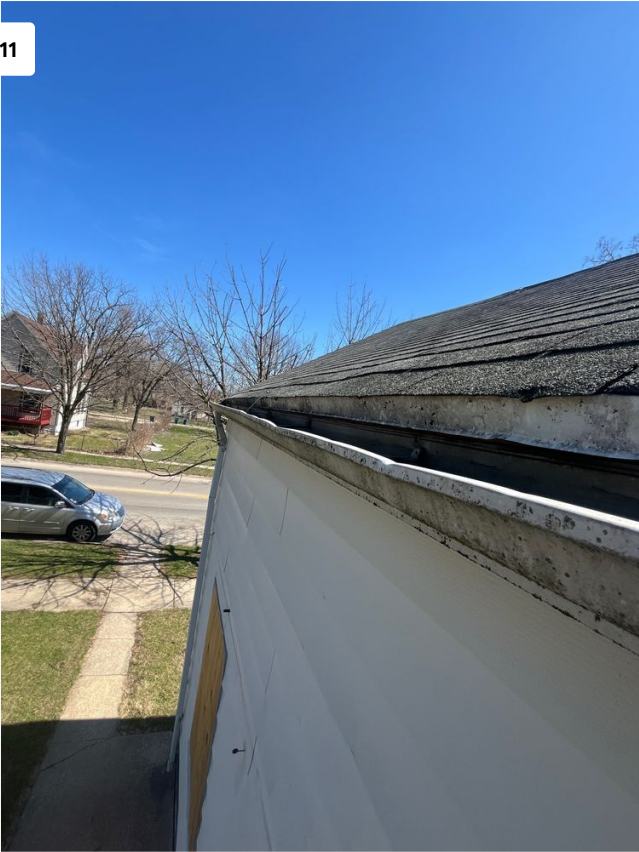
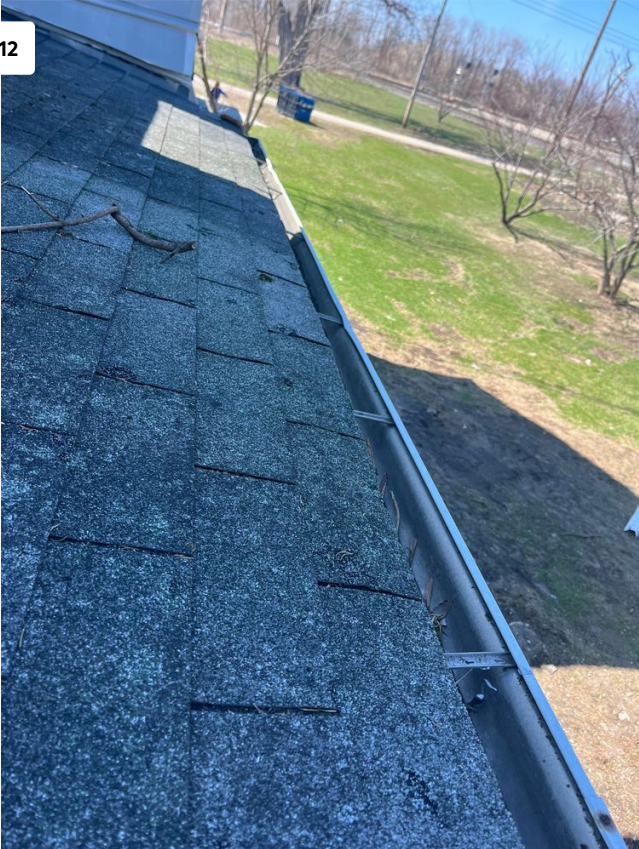
Gutters and downspouts were inspected on multiple elevations of the building. Damage consistent with large hail impact was observed throughout the gutter and downspout systems on both structures. The denting pattern and distribution across multiple elevations is consistent with the March 10 storm event and is not attributable to normal wear or pre-existing conditions.

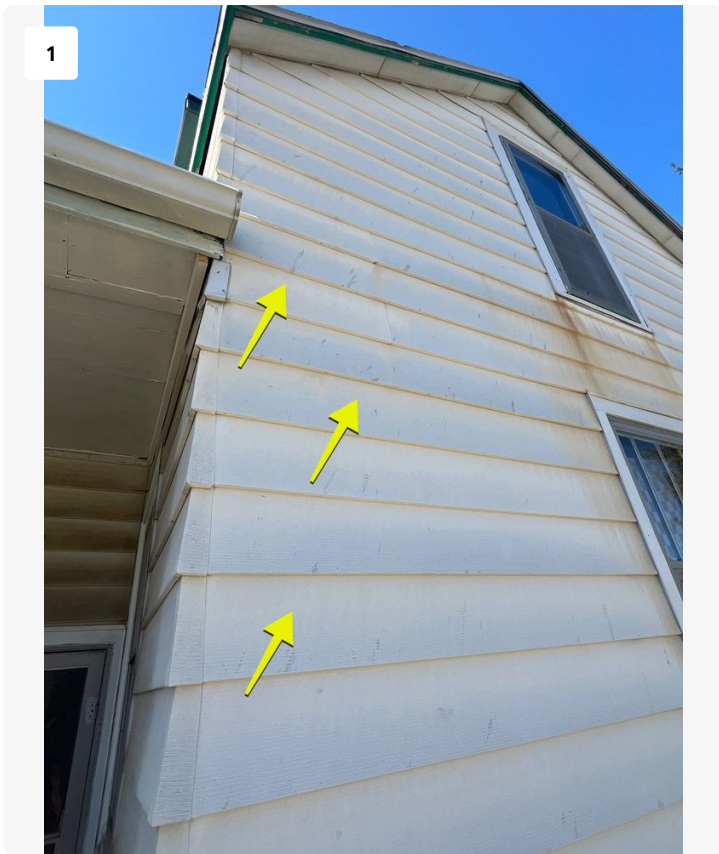
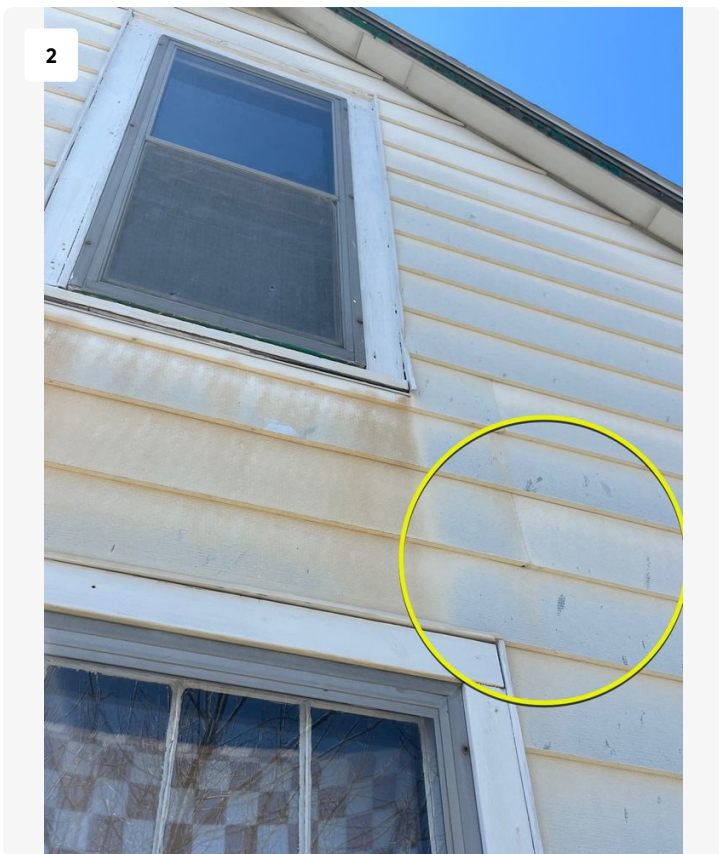
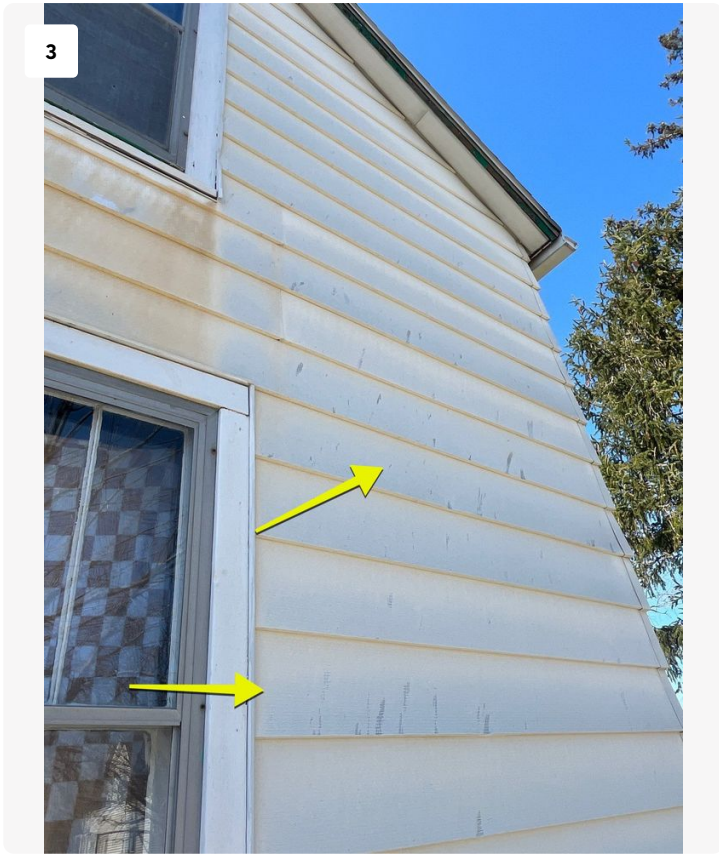
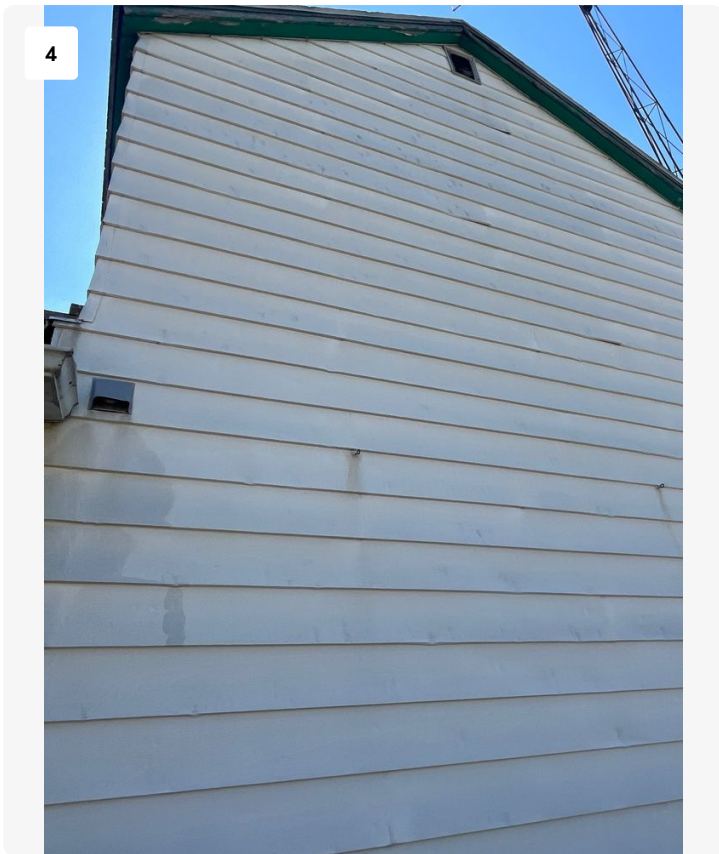
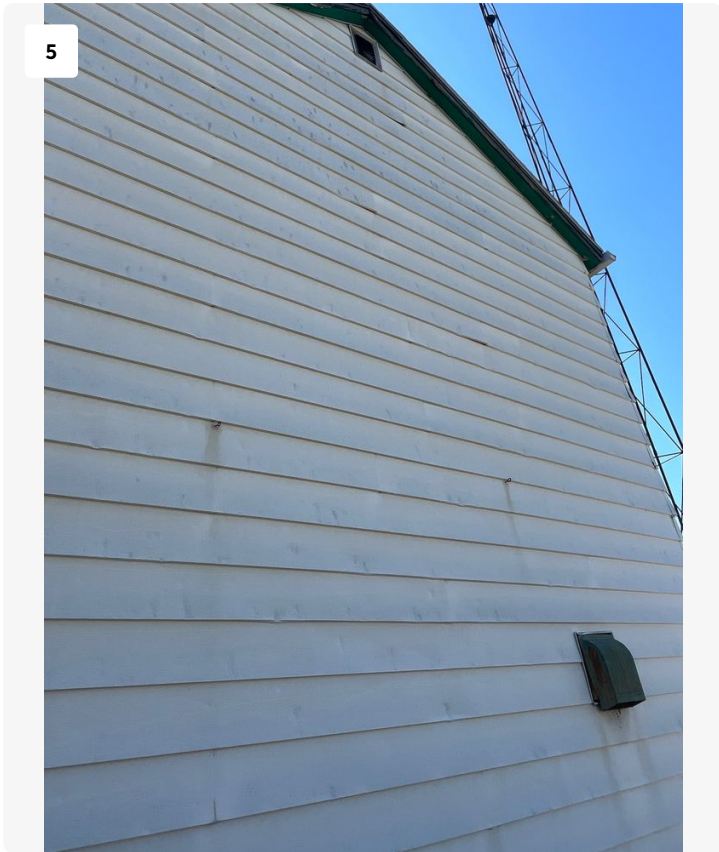
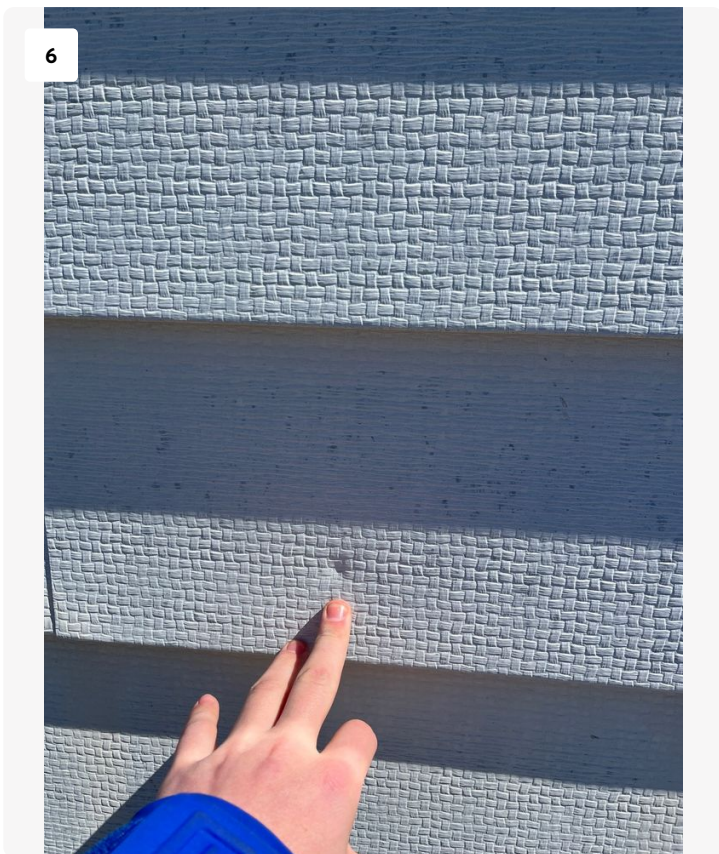
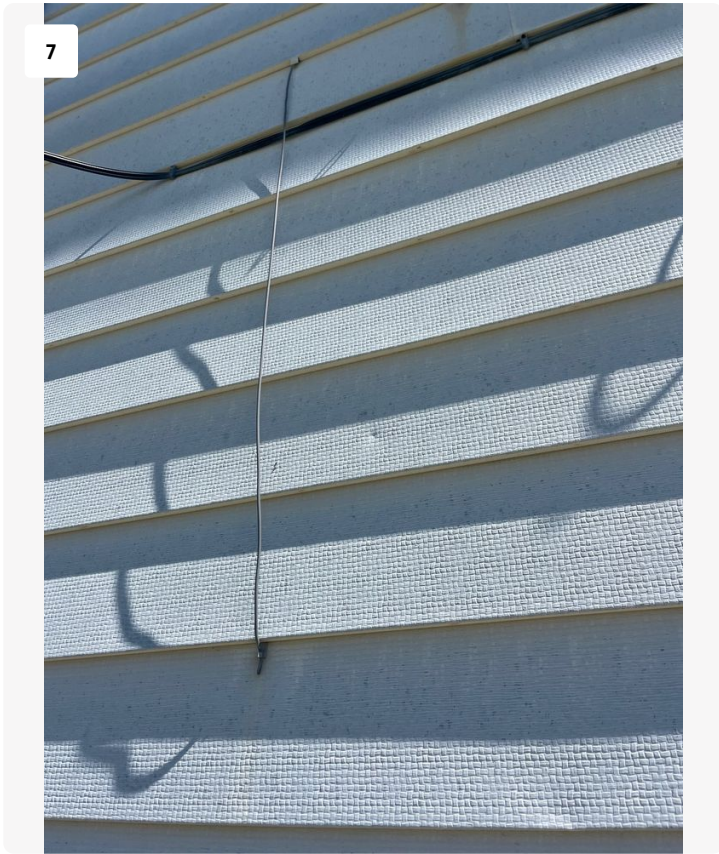
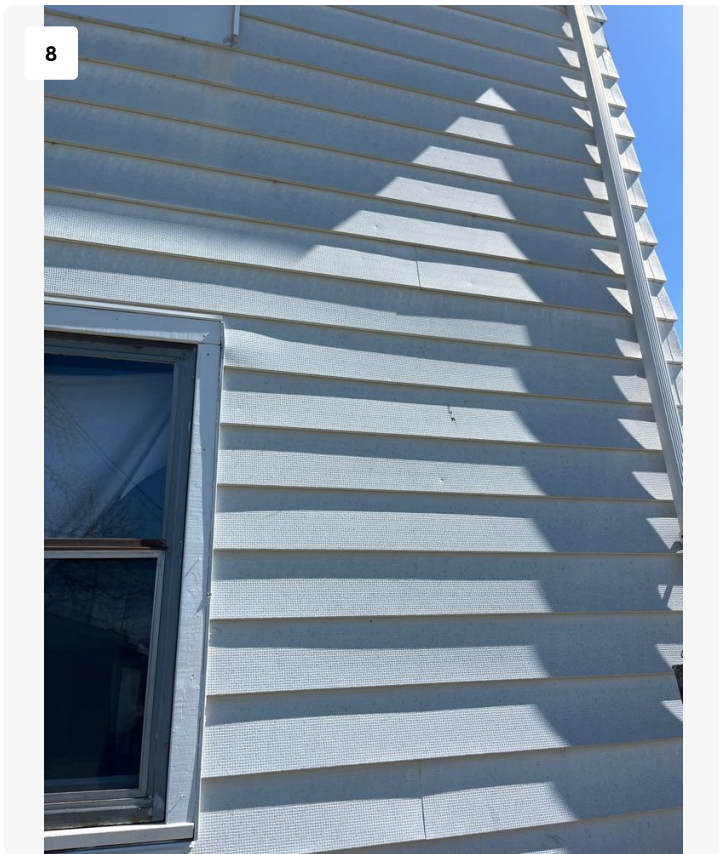
Vinyl siding on the building sustained hail damage across multiple elevations. Impacts consistent with large hail were observed on siding surfaces throughout the property. Fascia components were also affected by the storm event and sustained damage consistent with hail impact. The pattern and distribution of damage across the siding and fascia is consistent with the March 10 storm event and reflects the same storm activity documented across all other exterior surfaces.

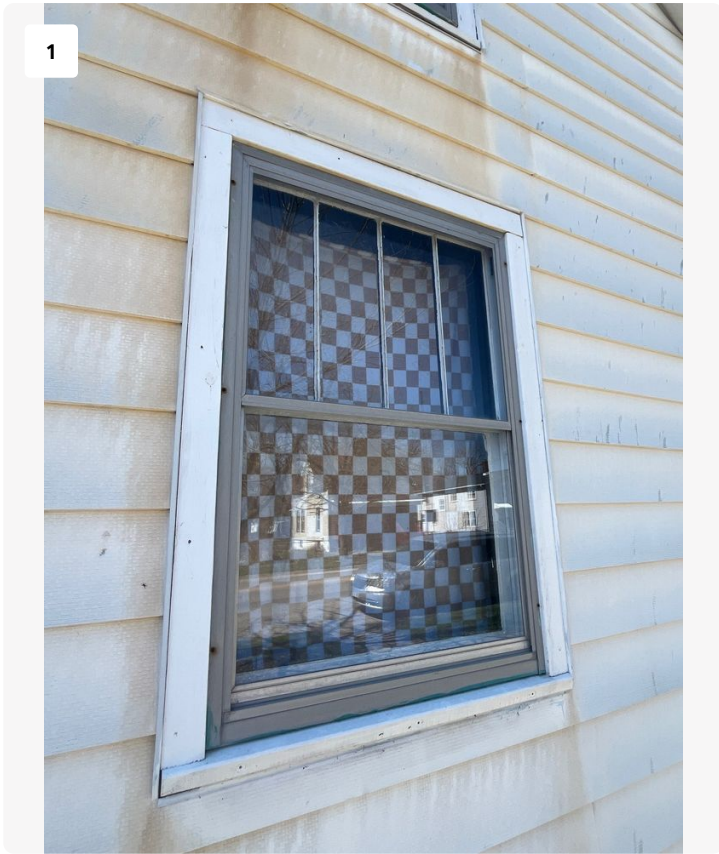
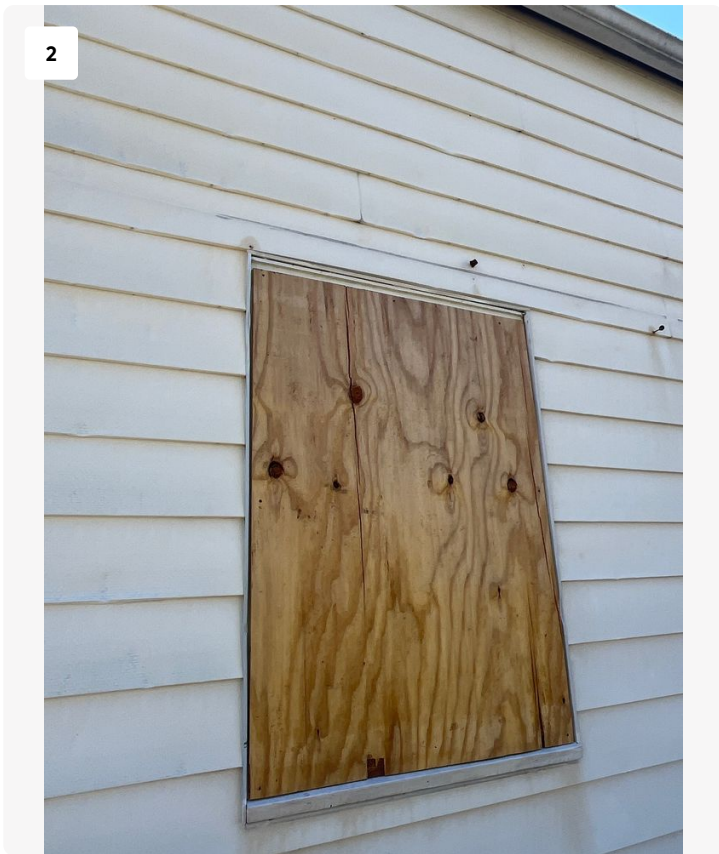
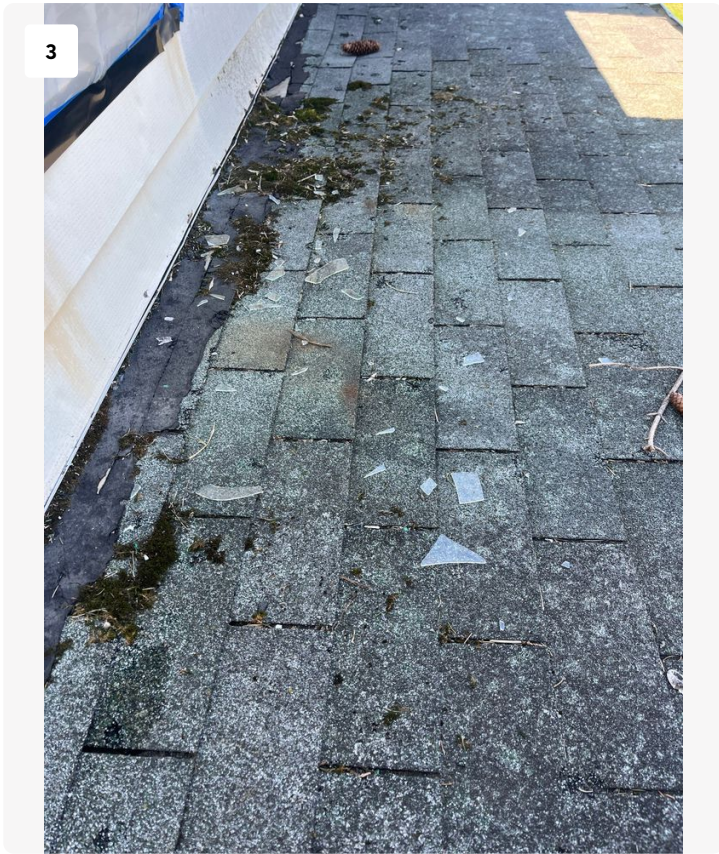
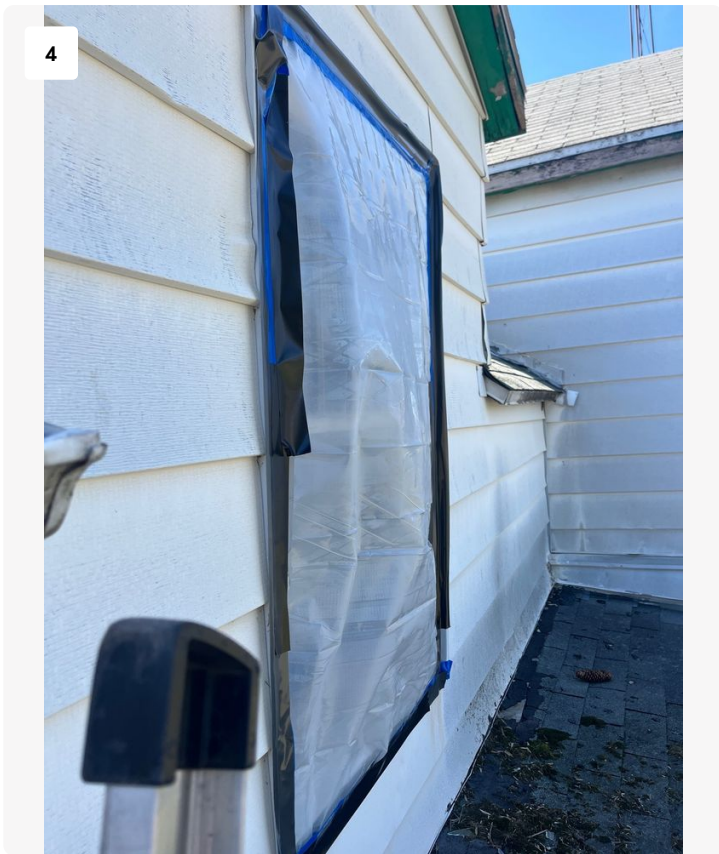
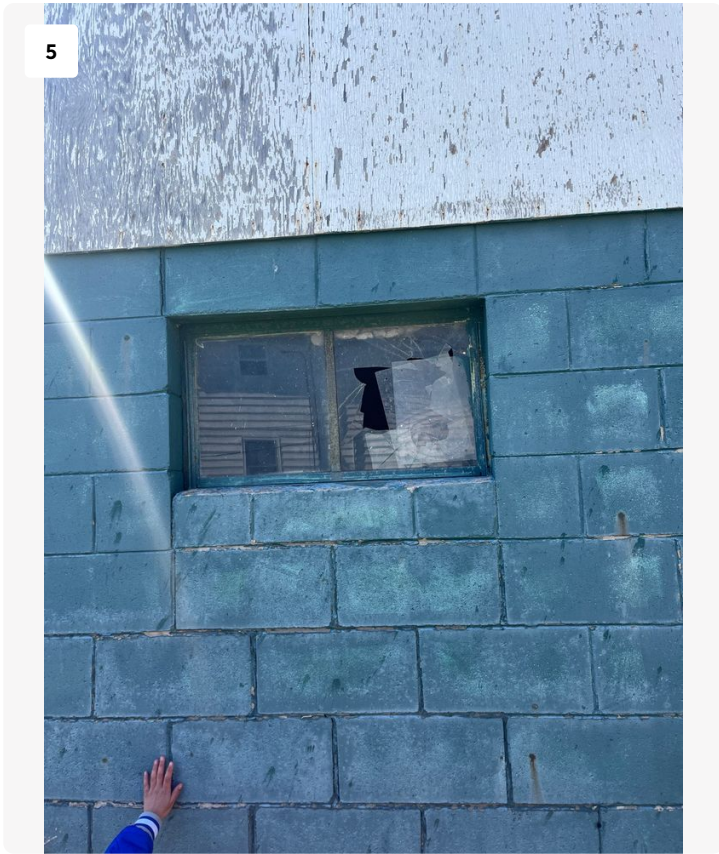
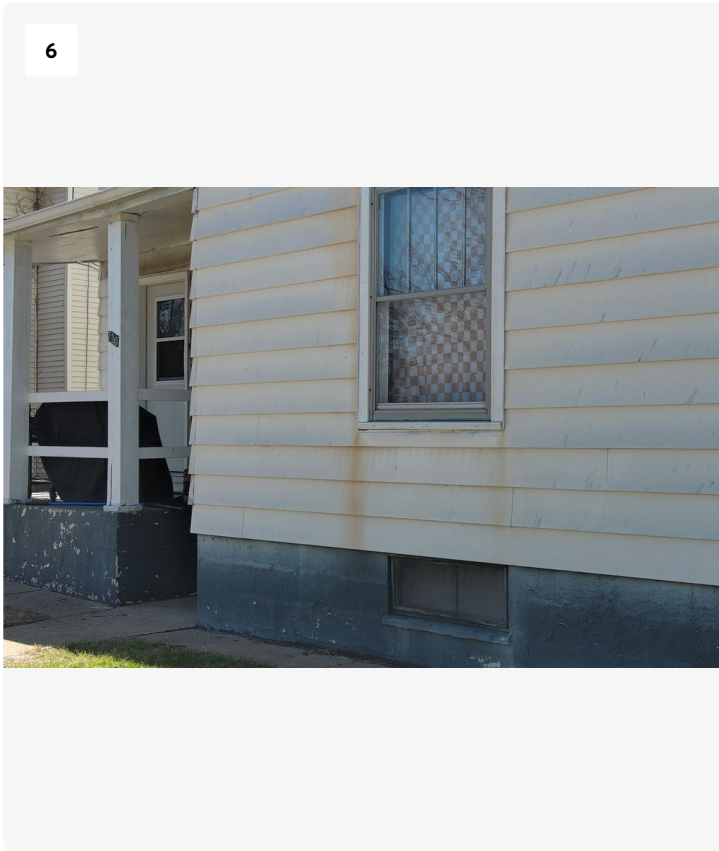
Window damage was among the most significant findings at this property. Window glass was broken and shattered by hail impact at multiple openings throughout the building. Window screens were blown out across the property, consistent with the force of the March 10 hail and wind event. The broken glass represents a direct breach of the building envelope and an immediate exposure point for moisture intrusion, wind-driven rain, and interior damage to the units. All window components, including frames, cladding, and hardware, should be thoroughly evaluated during the adjuster inspection, as additional damage beyond the broken glass and screens may not have been immediately apparent during the initial walkthrough.

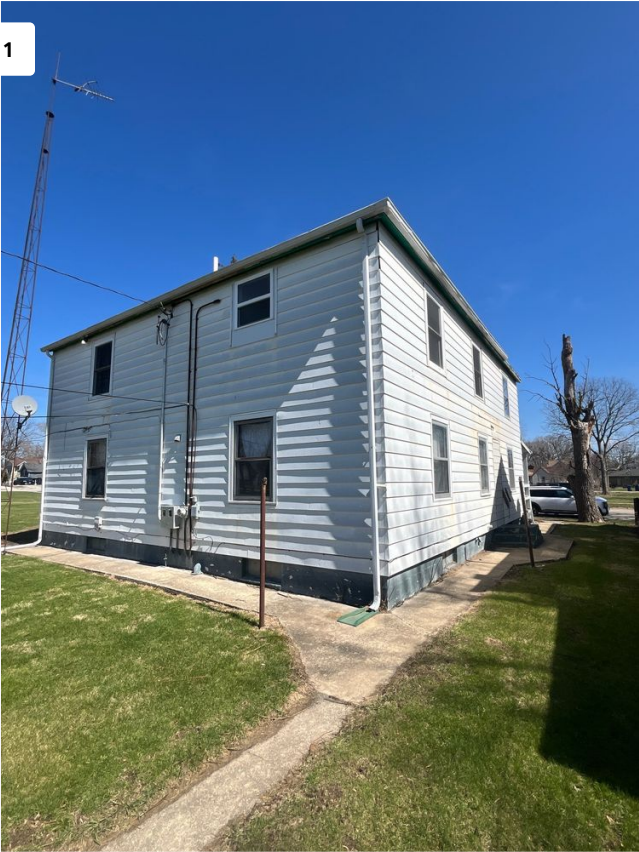
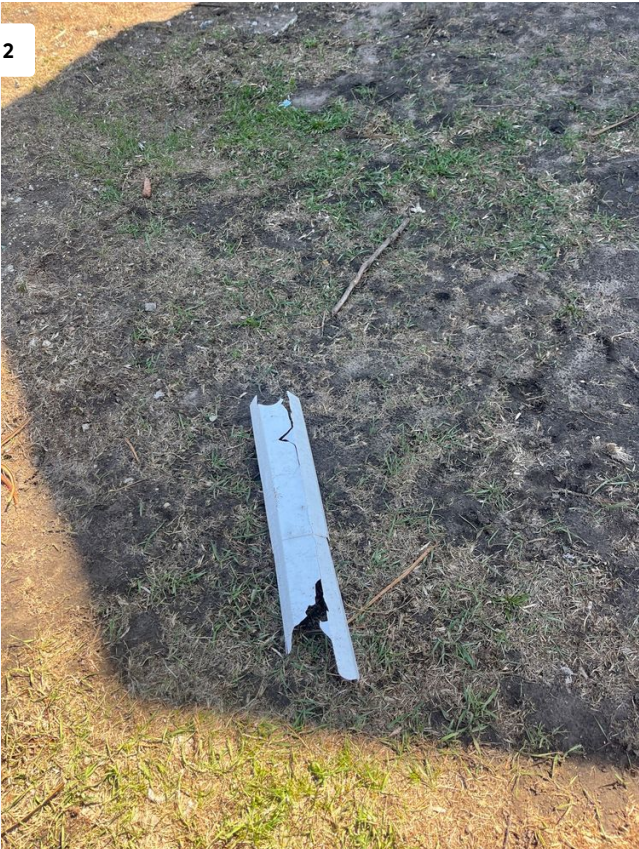
Soft Metals Soft metal components throughout the property, including but not limited to flashing, vents, and other exposed metal surfaces on both the building and the detached garage, sustained denting consistent with large hail impact from the March 10 storm event. The denting pattern observed is consistent with the storm activity documented across all other exterior surfaces.
